BUREAU OF SHIPS GROUP
TECHNICAL INSPECTION REPORT

⑥ OPERATION CROSSROADS.
U.S.S HUGHES (DD410).
TEST BAKER.

VOLUME II [u] ⑧

USS HUGHES (DD410)

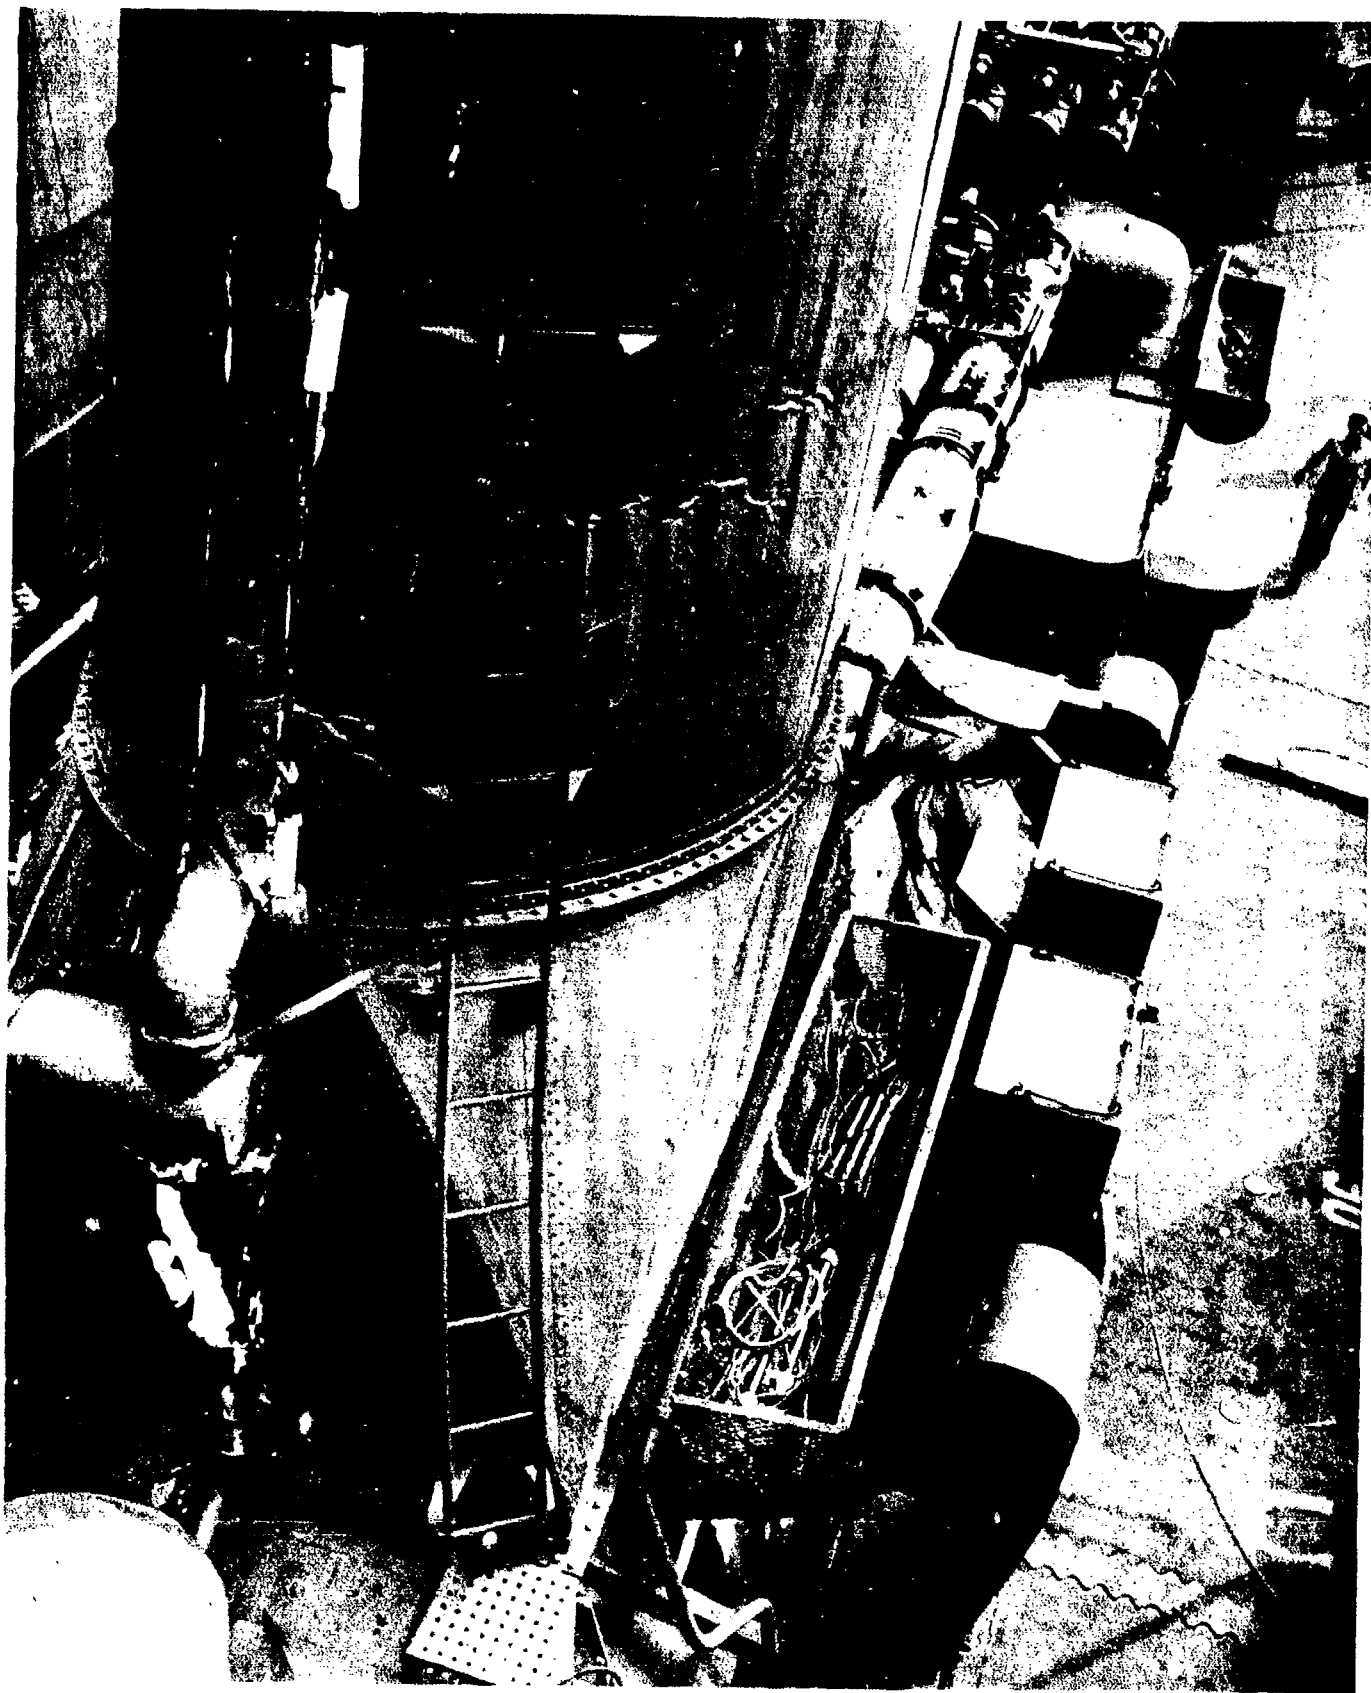
AA-CR-65-1849-10. Test A damage to stack, looking aft, down and slightly to starboard.

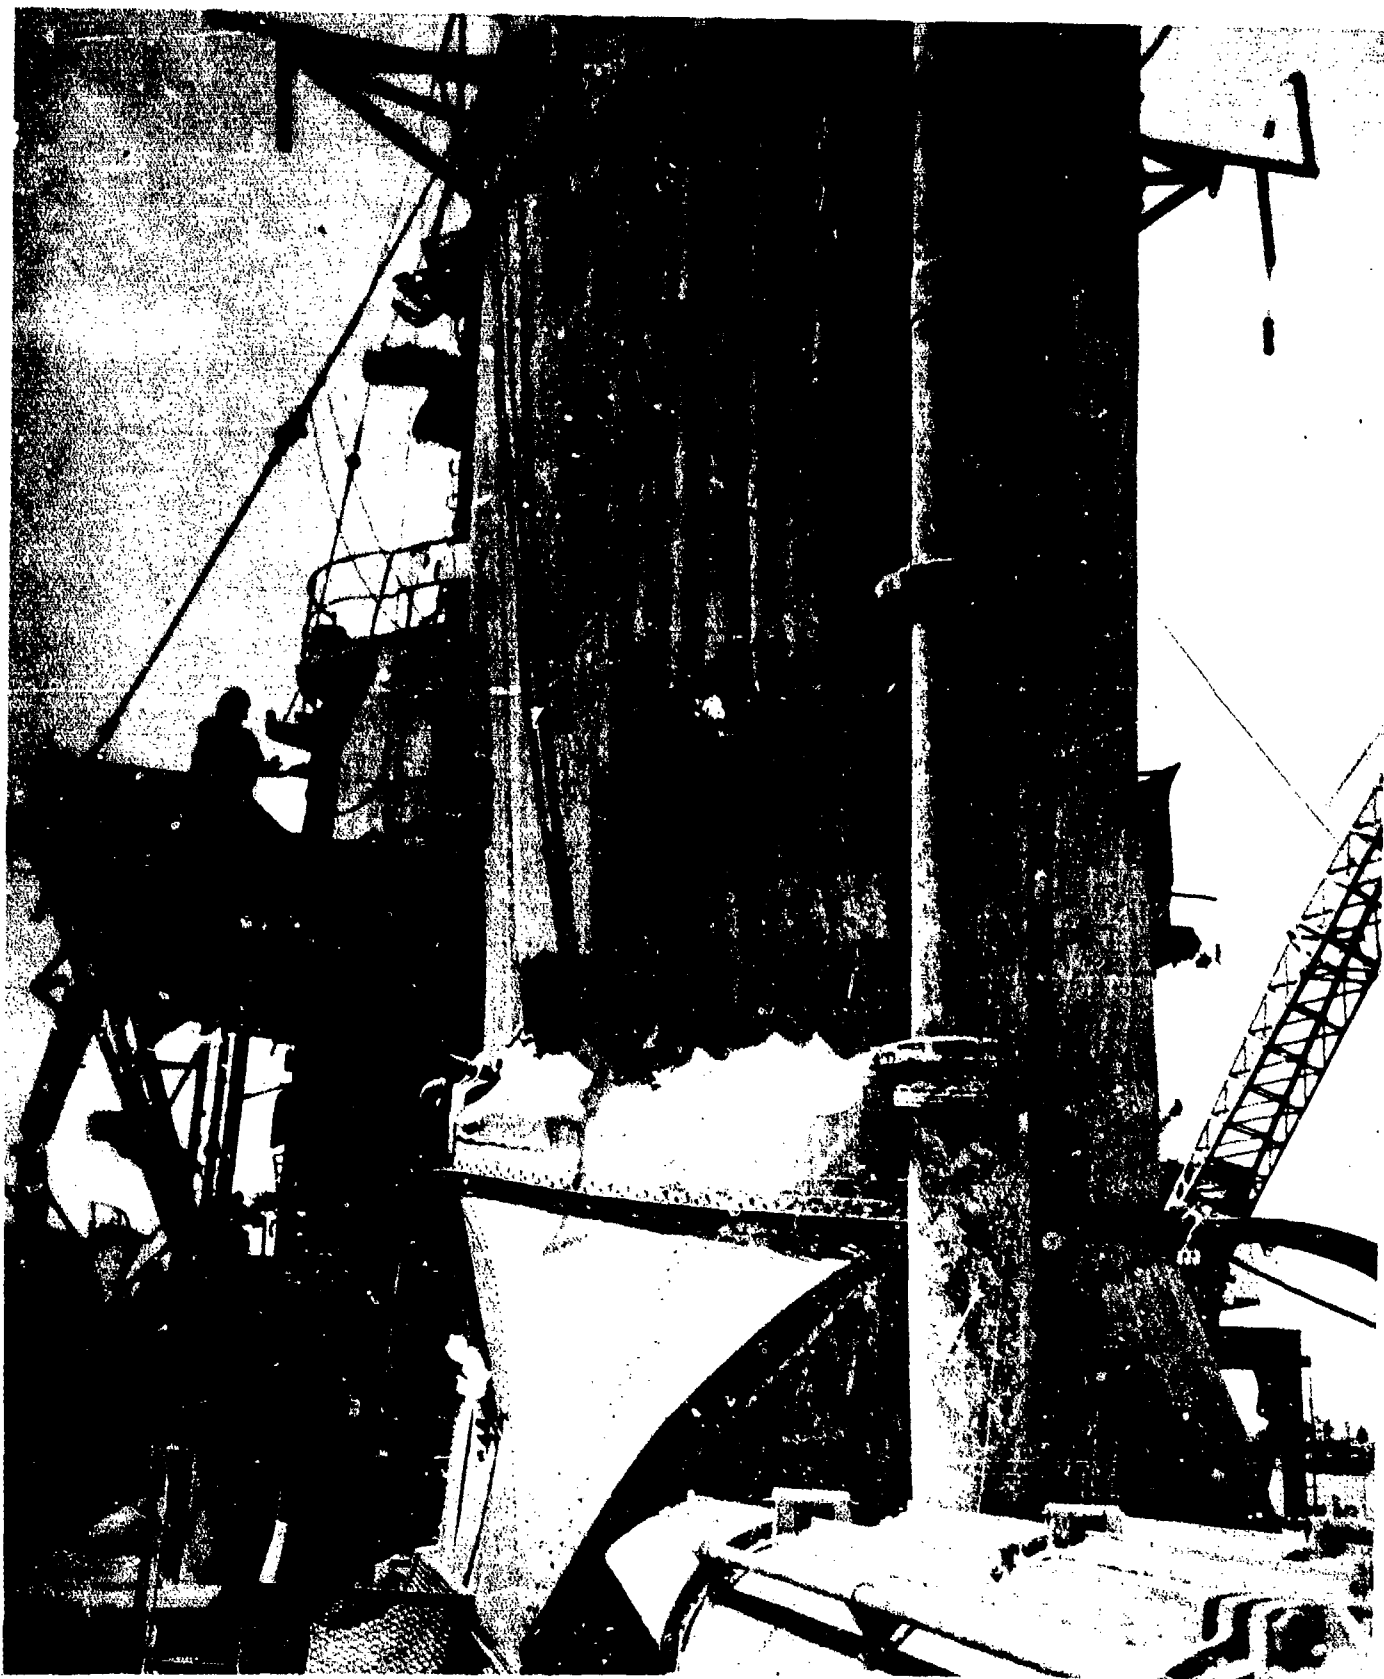
AB-CR-76-2077-9. Looking forward from port side of midship deck house at damage to port side of stack.

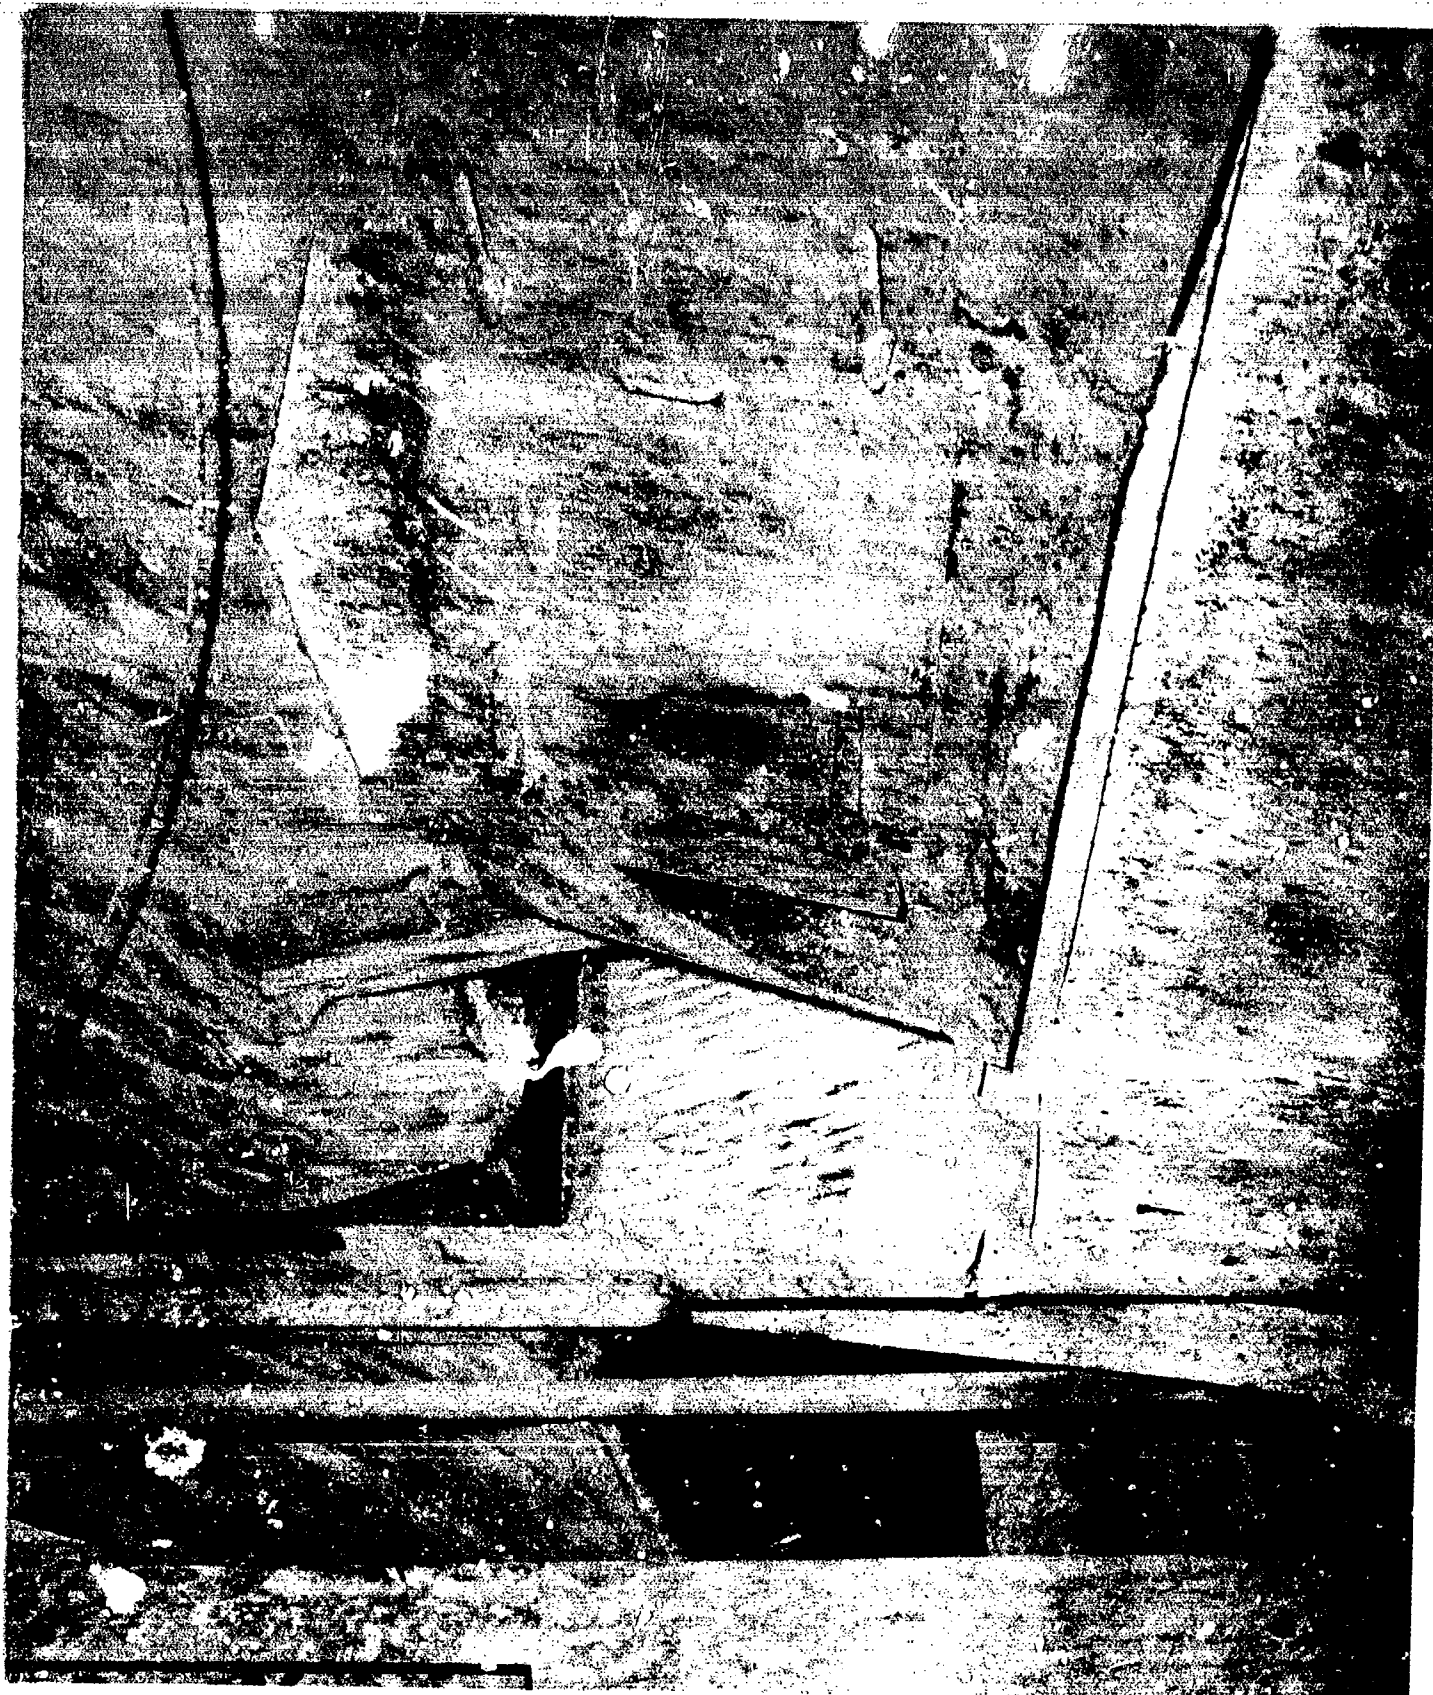
AB-CR-76-2077-3. Looking aft and to port at damage to starboard side of No. 2 boiler uptake.

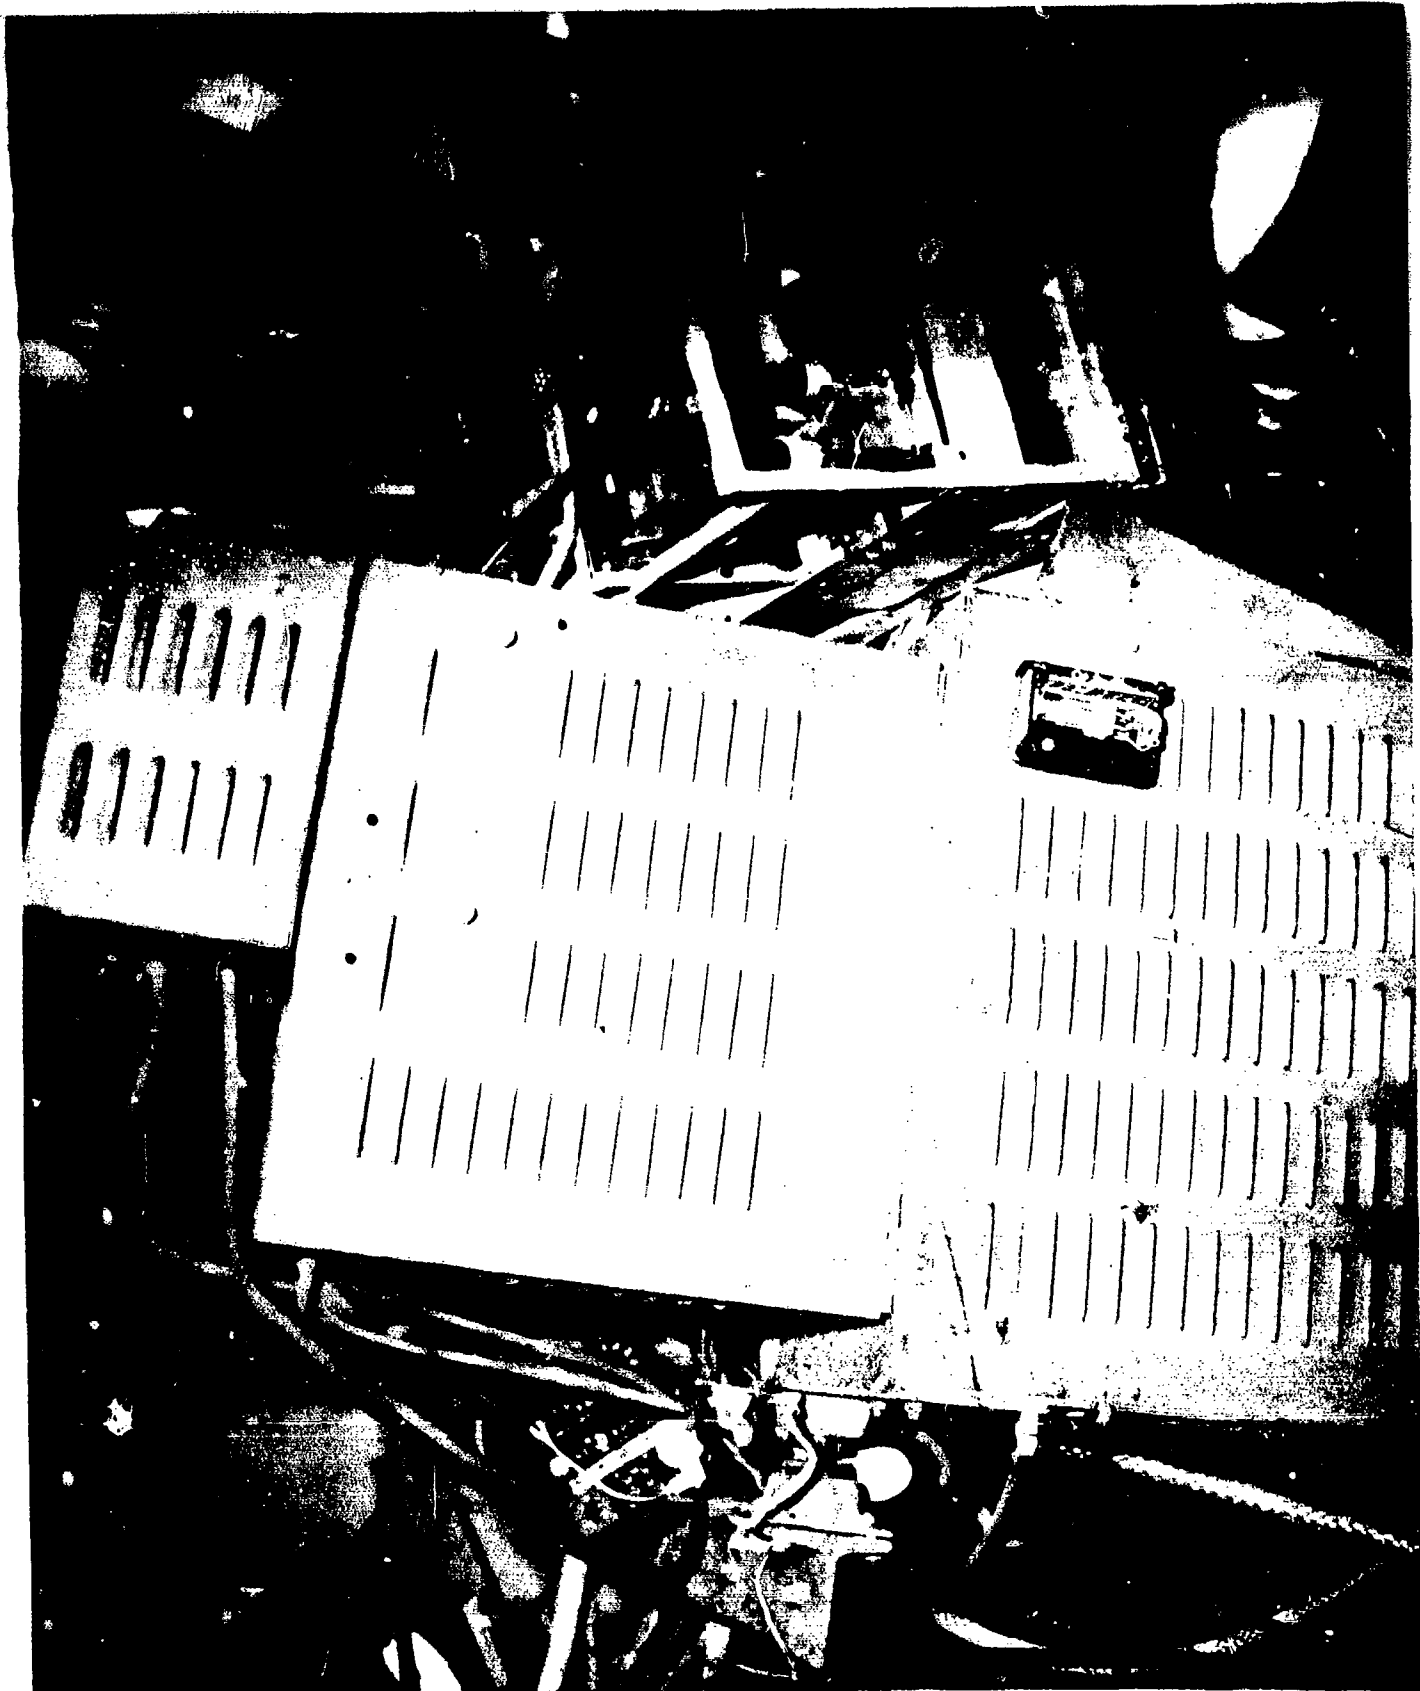
AB-CR-78-1951-8. Equipment damage in deck house on superstructure deck.

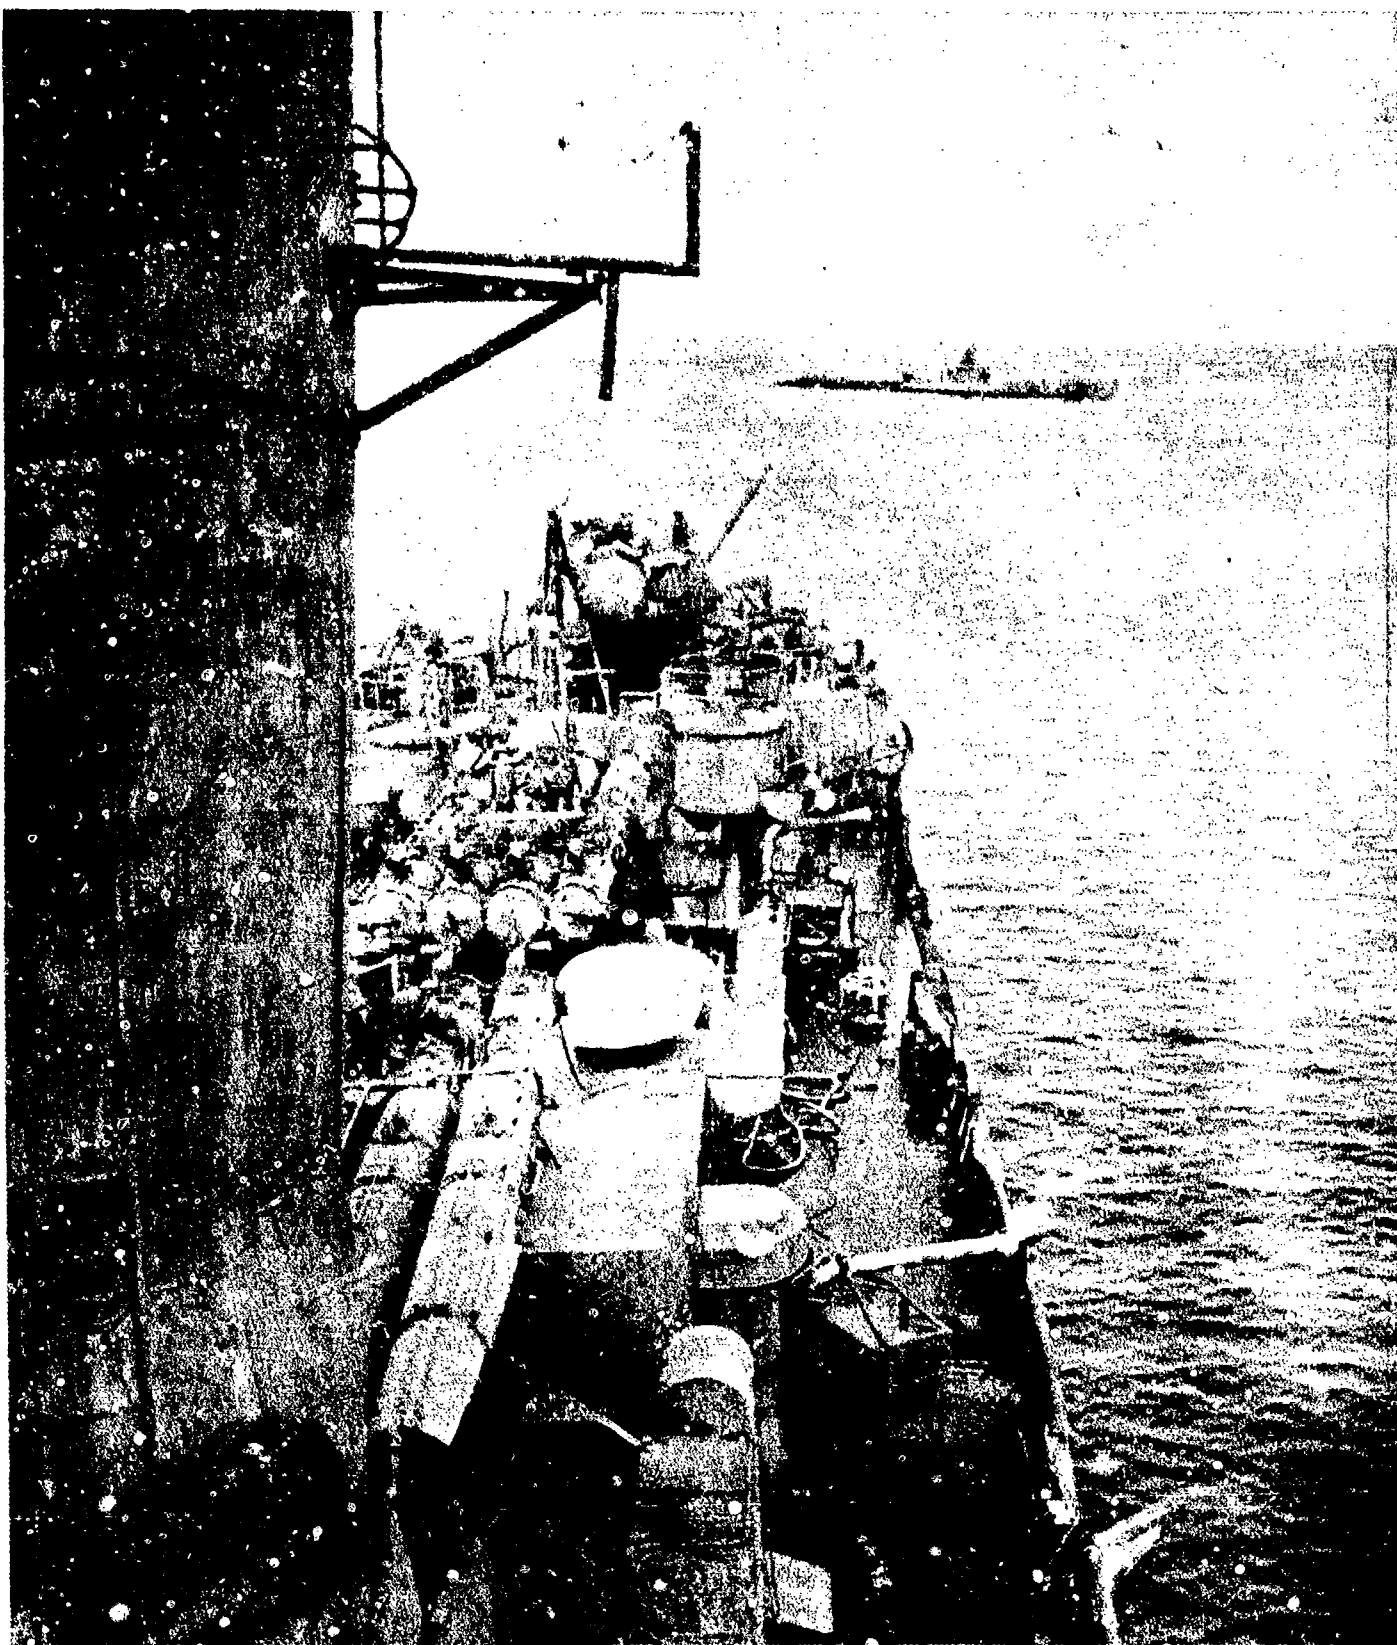
AB-CR-100-4204-5. Looking down and aft to main deck showing port side of stack and damage to port.

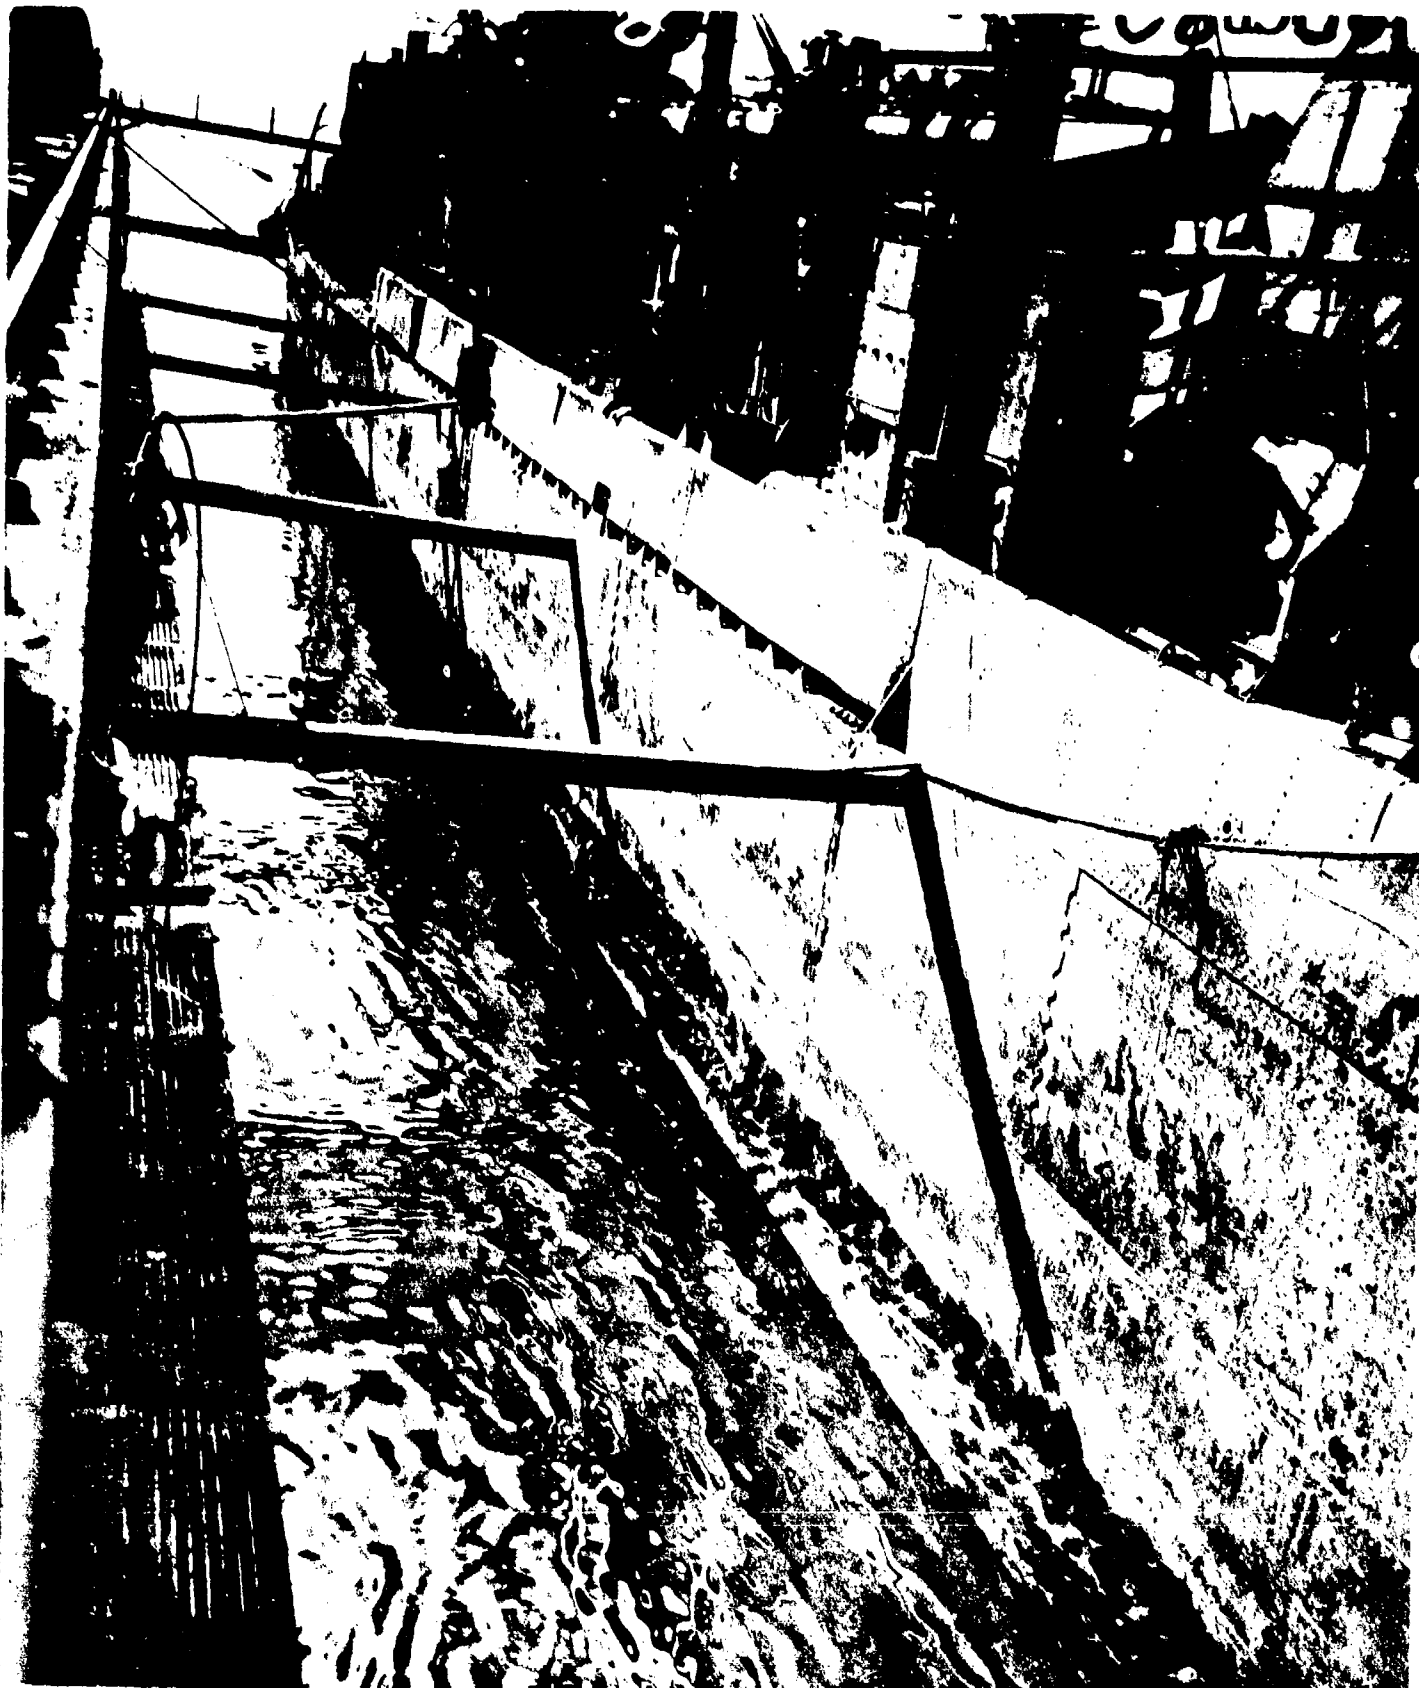
AB-C^R-82-4223-8. View of starboard shell plating from frame 75 aft and damage to uptake.

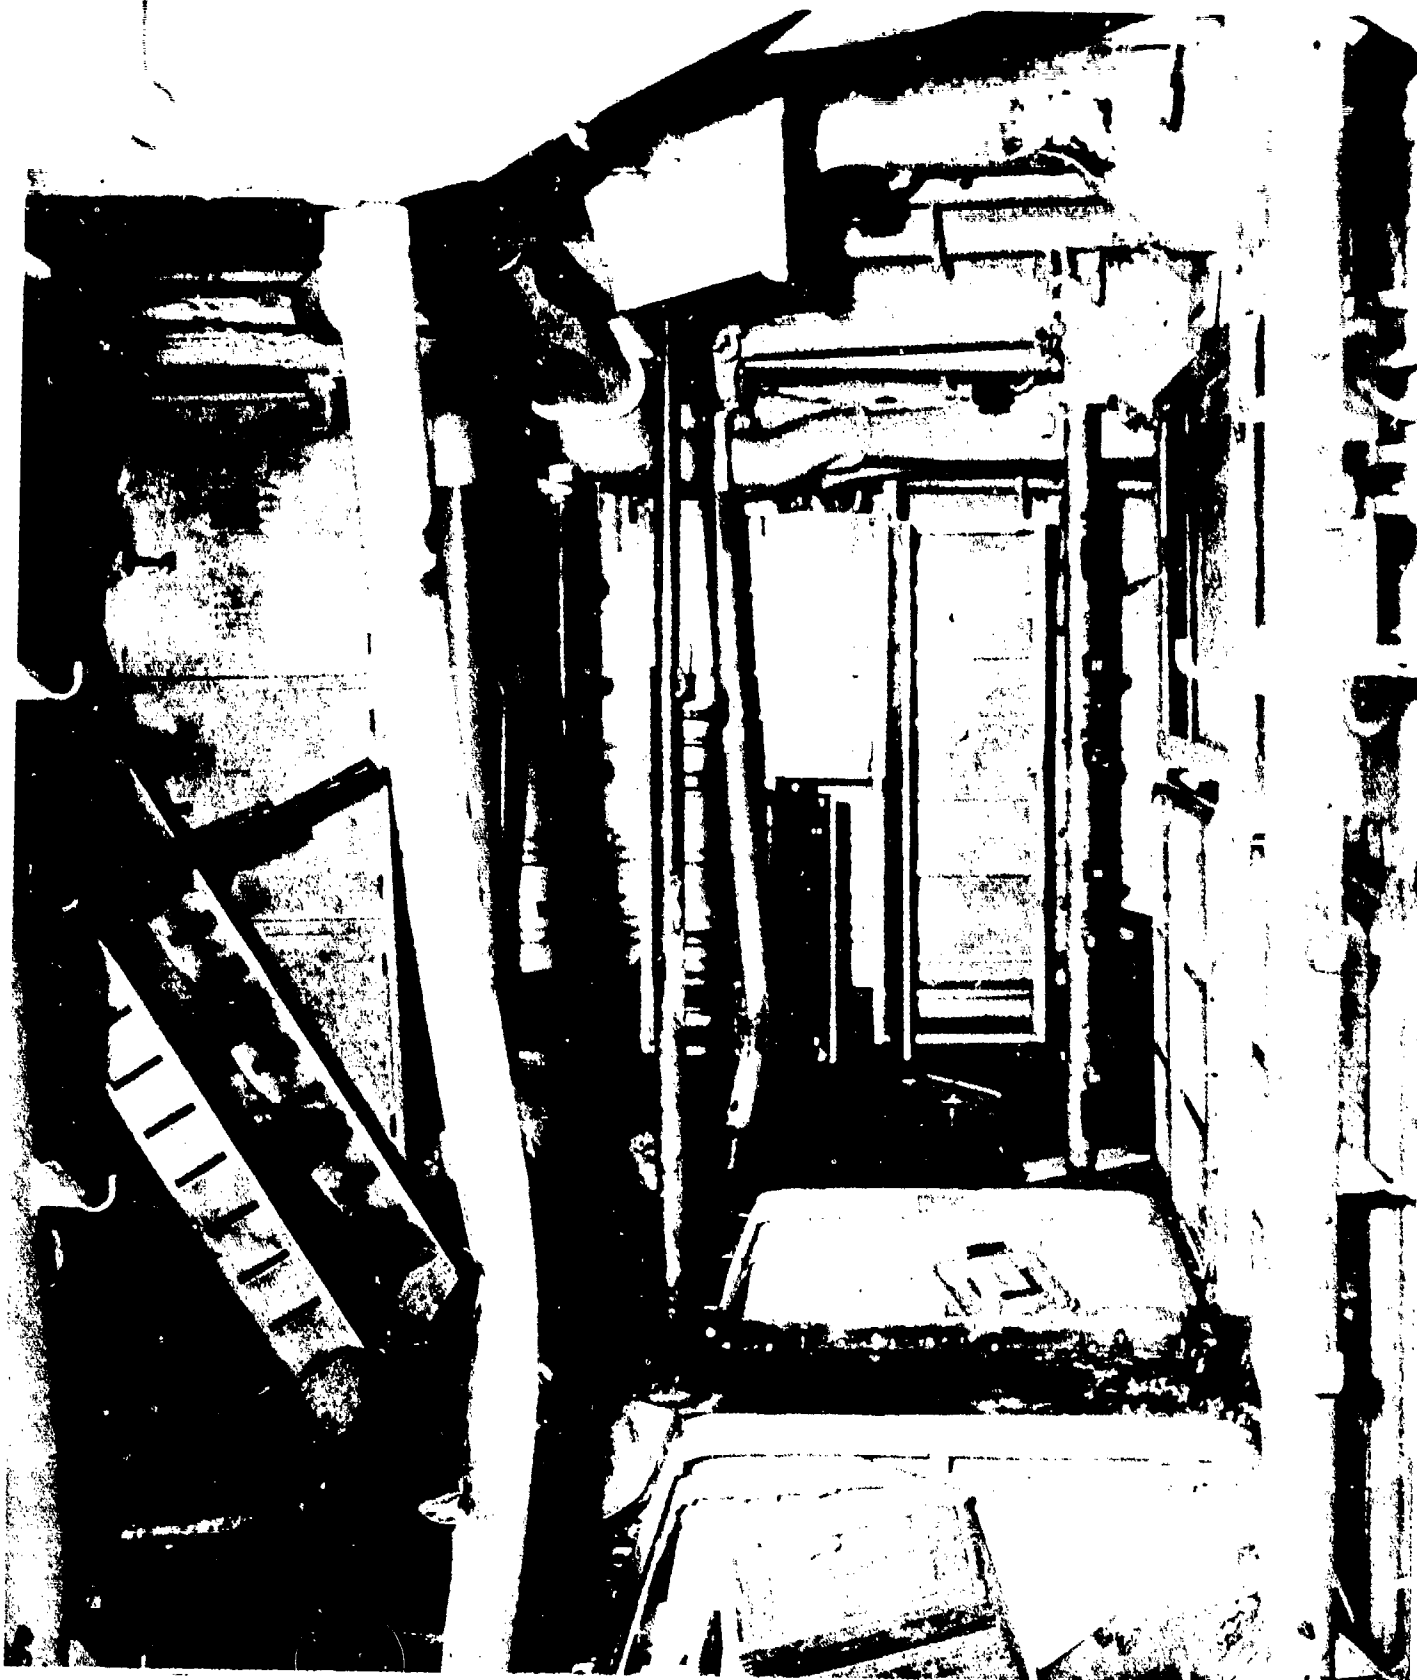
AB-CR-100-4208-4. Buckled stanchions at frame 175, between main deck and first platform looking to port in crews quarters and damage to main deck longitudinals at after side of bulkhead 173.

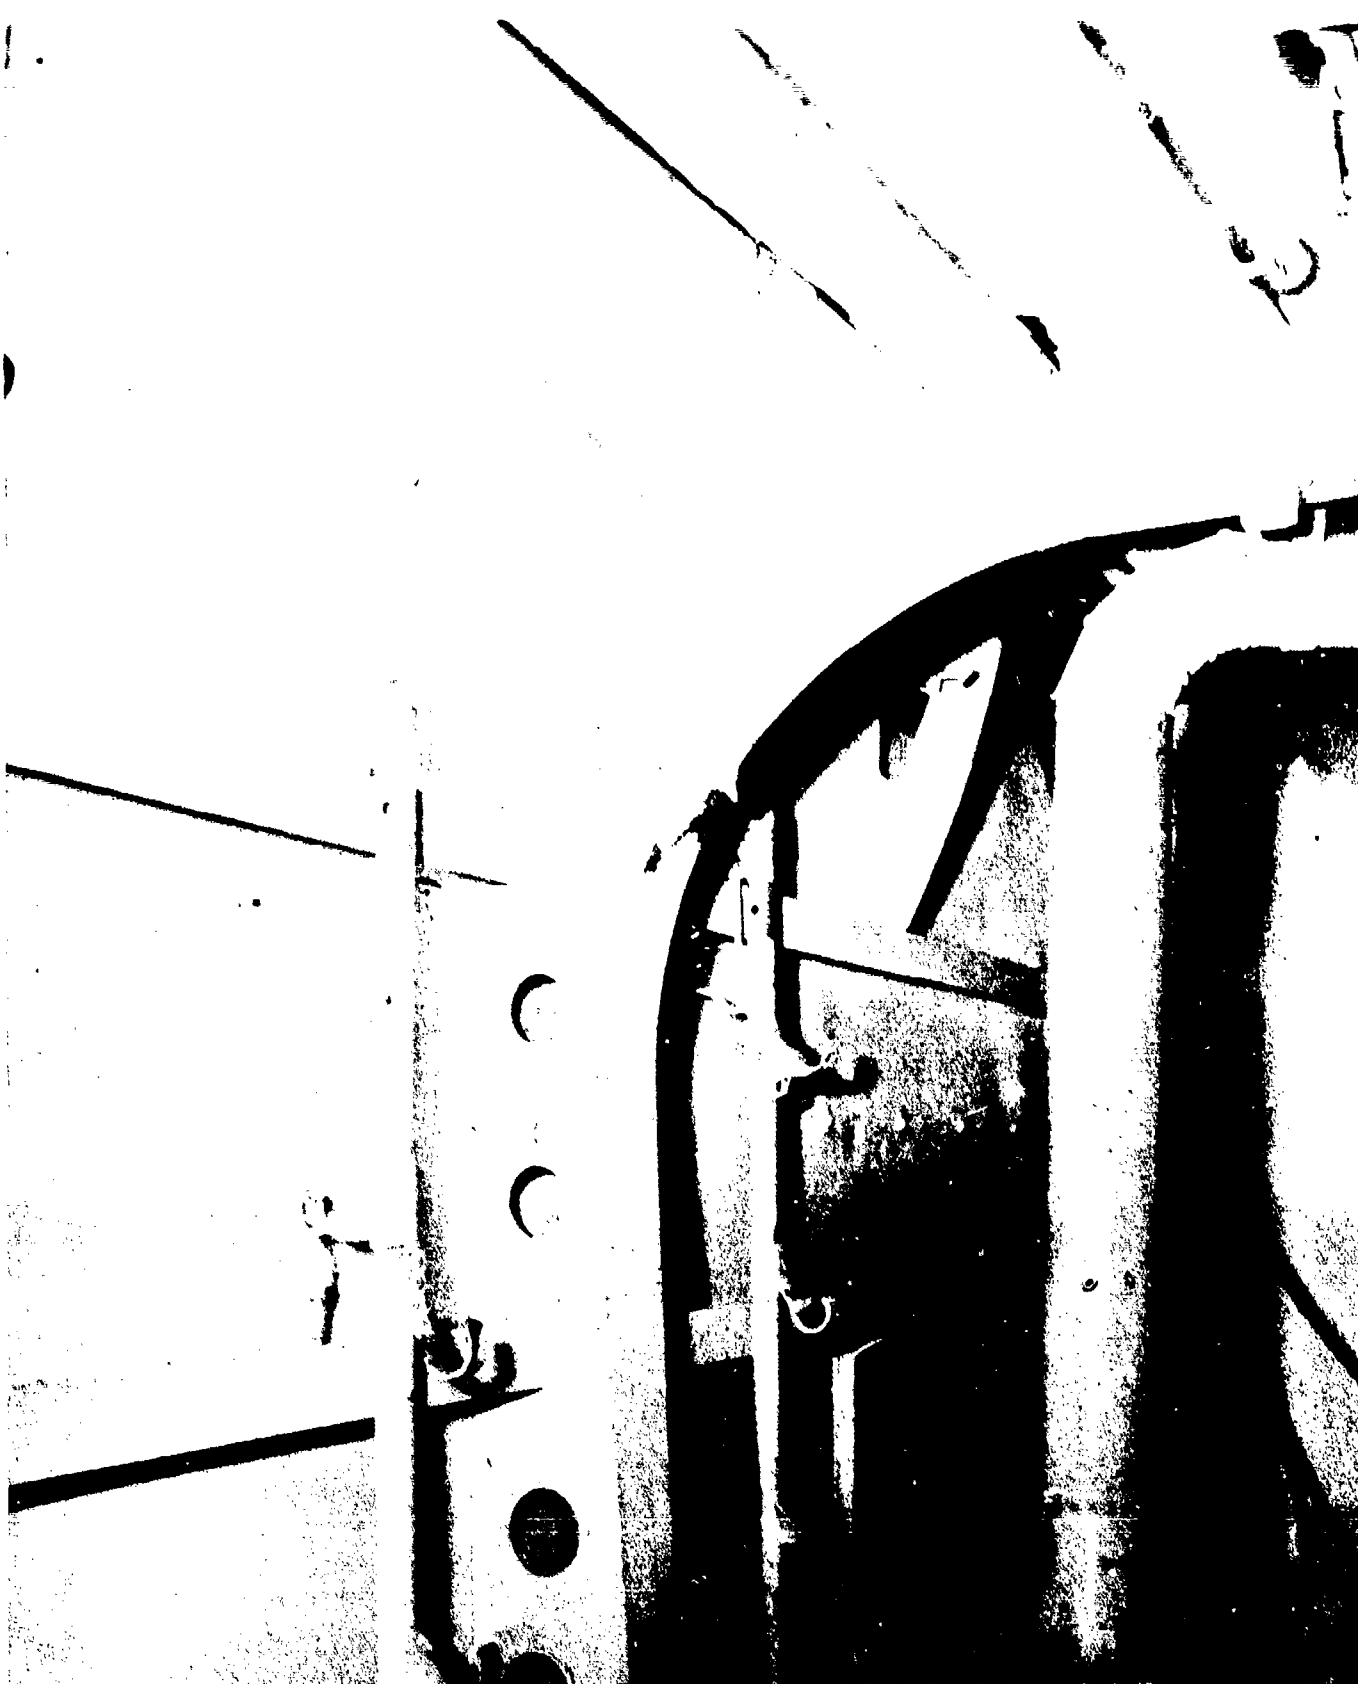
AB-CR-100-4208-9. Damaged web frame 175, port side looking forward on first platform in crews quarters.

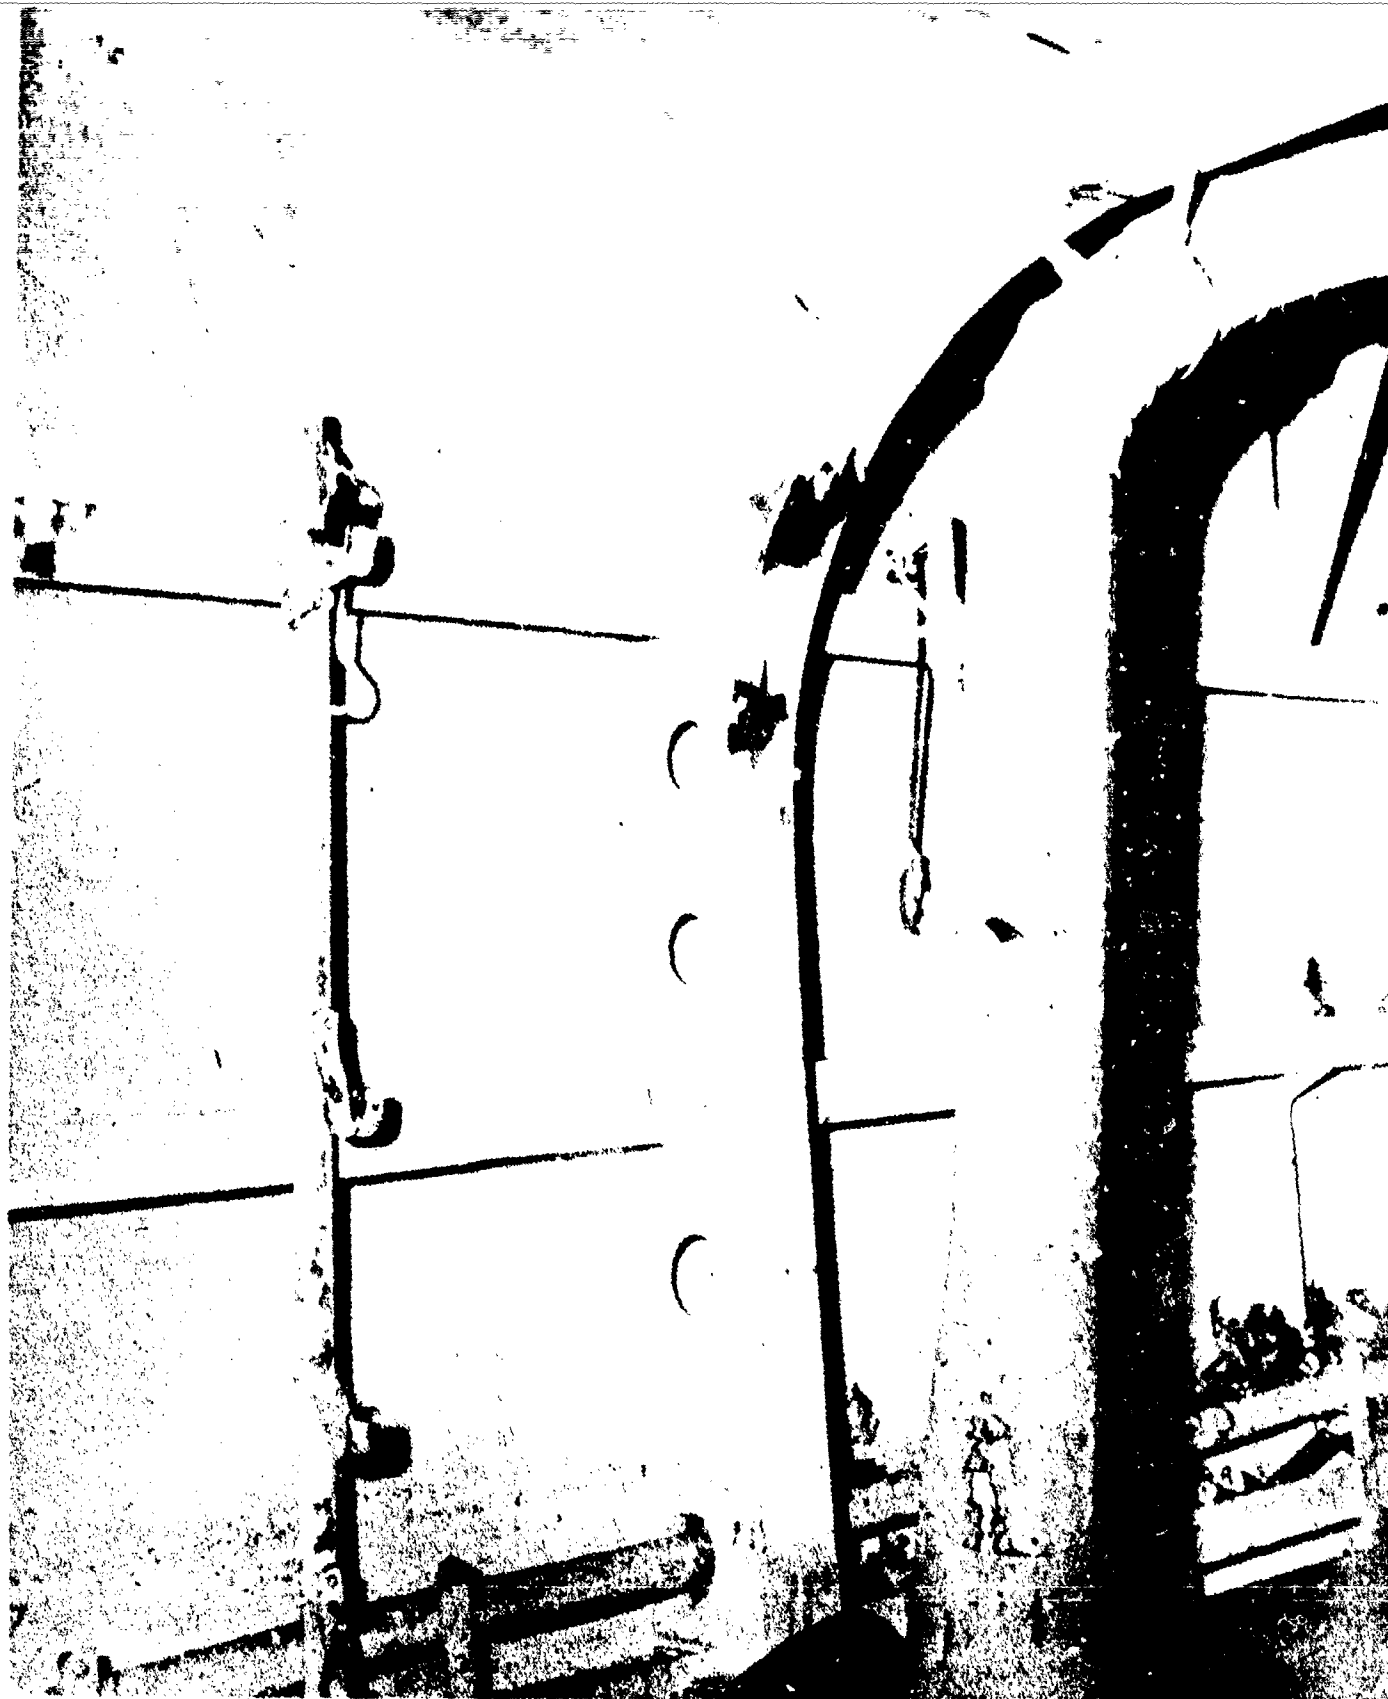
AB-CR-100-4208-7. Damaged web frame 175, starboard side looking aft on first platform in crews quarters.
